BUILDING INSPECTION REPORT

321 Zero Pl Anywhere USA 11111

Absolute Home Inspection, Inc.

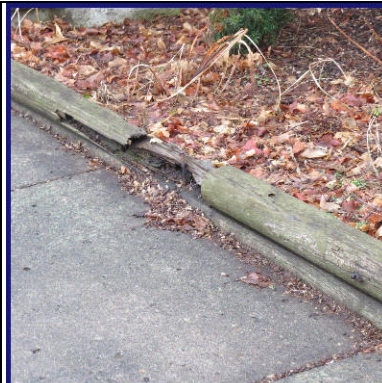
This has some rotting timbers which should be replaced. This wall does not affect the house.

Rotting timbers

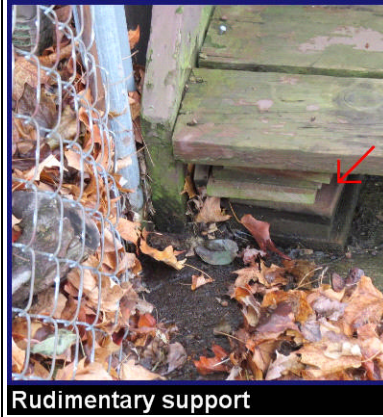
The deck steps are tilted to one side, and there is a rudimentary stack of wood supporting the bottom tread. These steps are lack solid attachment at the top. We recommend having these steps further evaluated by a qualified carpenter, followed by improvements or replacement as deemed necessary.

Rudimentary support

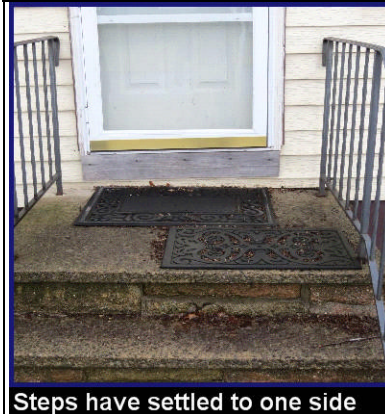
The front steps are satisfactory, though have settled to one side over the years. Monitor in the future.

Steps have settled to one side

Also, we recommend the seal at the house juncture be improved.

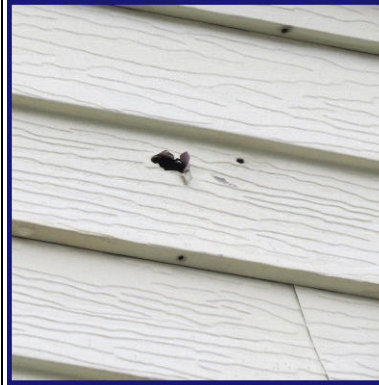
There are a few damaged sections noted. These should be sealed or replaced.

Damaged siding

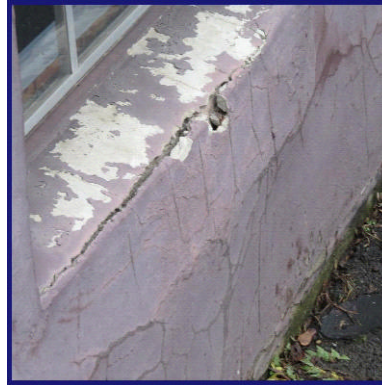
Some of the parging on the foundation is deteriorating around the perimeter of the building. This will continue to deteriorate if not repaired. Removal of all loose materials is advised, followed by reparging, as necessary, to prevent future damage.

Damaged parging

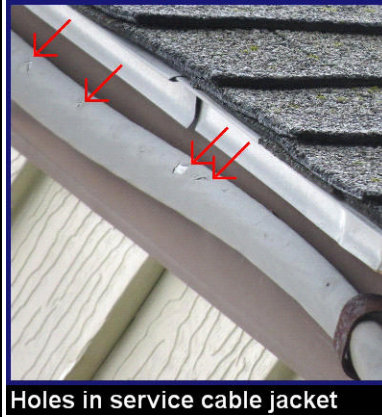
Service cable jacket is frayed in areas. NOTE: This condition can result in the exposure of electrical wiring, as well as water entry into the panel box. We recommend that you have this referred to a qualified electrician for replacement. This should be done as soon as feasible.

Holes in service cable jacket

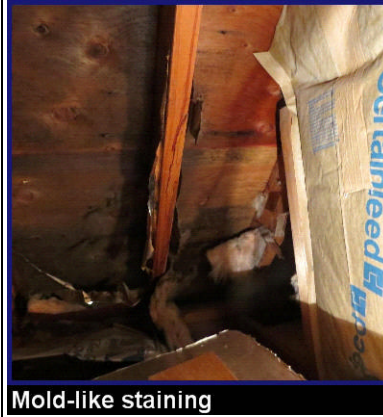
Mold-like staining is present on the underside of the roof decking in areas. This is indicative of poor air sealing of the attic floor, and well as the possible need for additional insulation. Our inspectors are not mold experts. There are experts who can test and identify this substance, as well as provide further information on possible health risks. Such an expert should be consulted prior to settlement with regarding any questions or concerns.

Mold-like staining

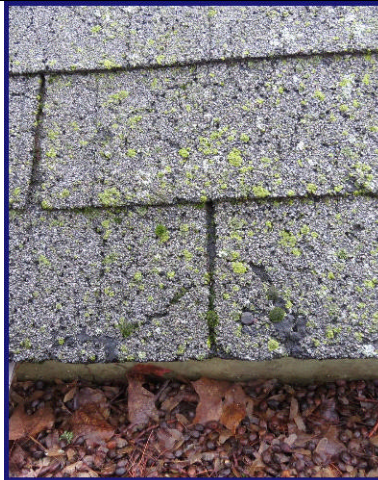
3. Cracking and clawing of shingles are the result of long term weathering and an advanced shingle age. Felts are showing through in areas. Roof is at the end of its useful life. Refer to a roofer at this

Shingle deterioration

time for further evaluation, estimates and replacement as soon as feasible.

Due to the condition of the current roof shingles, we recommend stripping at time of replacement.

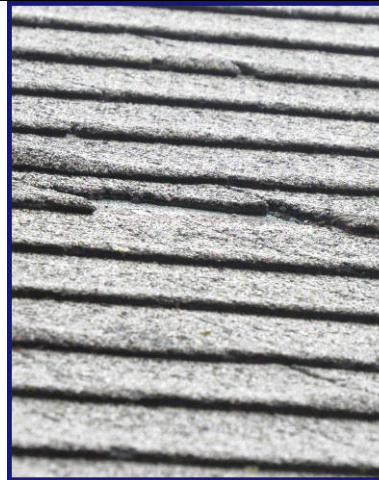
Missing shingle

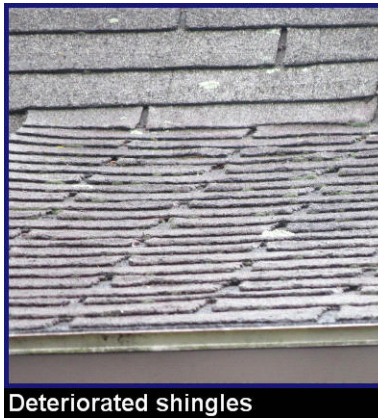
Deteriorated shingles

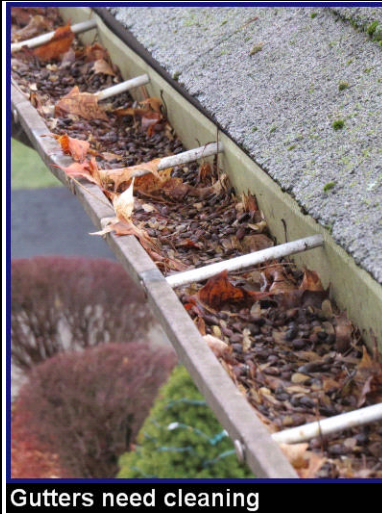
Debris is present in gutters. These should be cleaned out at this time, and on a regular basis thereafter.

Gutters need cleaning

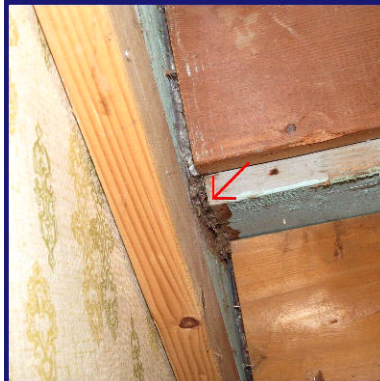
4. Stairs are in need of repair: The stair stringers are spreading apart in areas. This, over time, can allow for treads to become disconnected from the stringer. These should be drawn back together and resecured. At that time, have the treads that are pitched forward leveled.

Stairs need repairs/Poor tread bearing

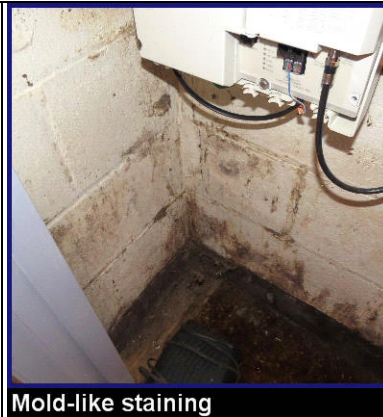
Mold-like staining was also noted in areas. Our inspectors are not mold experts. There are others who can test, identify and provide further information on the potential health concerns of these areas. Consult with an expert with all related questions or concerns.

Mold-like staining

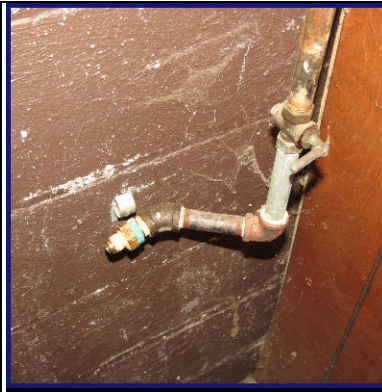
There is a missing cap on the gas line at the laundry. If this is NOT to be utilized for a dryer, it should be capped.

Missing gas line cap

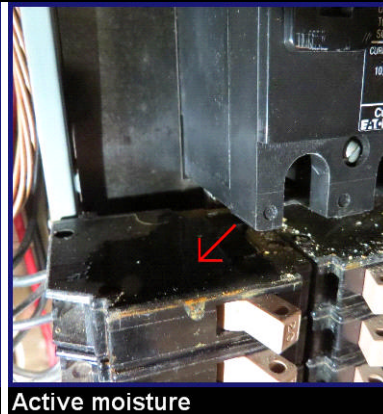
Active moisture is present in the panel box. This is probably caused by the damage to the cable jacket on the exterior. Have this addressed by an electrician.

Active moisture

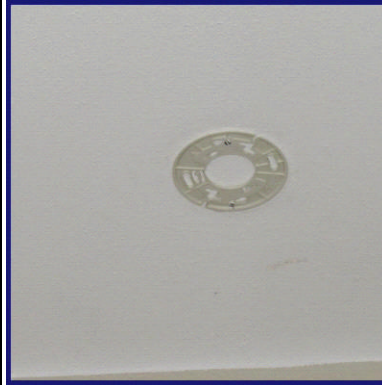
Missing smoke detector
